USAARL REPORT NO. 77-7

AEROMEDICAL EVALUATION OF UH-1 INTERNAL ADVANCED PERSONNEL RESCUE HOISTS
WESTERN GEAR CORPORATION HOIST MODELS 42277R1 AND 42305R1
BREEZE CORPORATION HOIST ECP-720 MODIFICATION

February 1977

US Army Aeromedical Research Laboratory
Fort Rucker, Alabama 36362

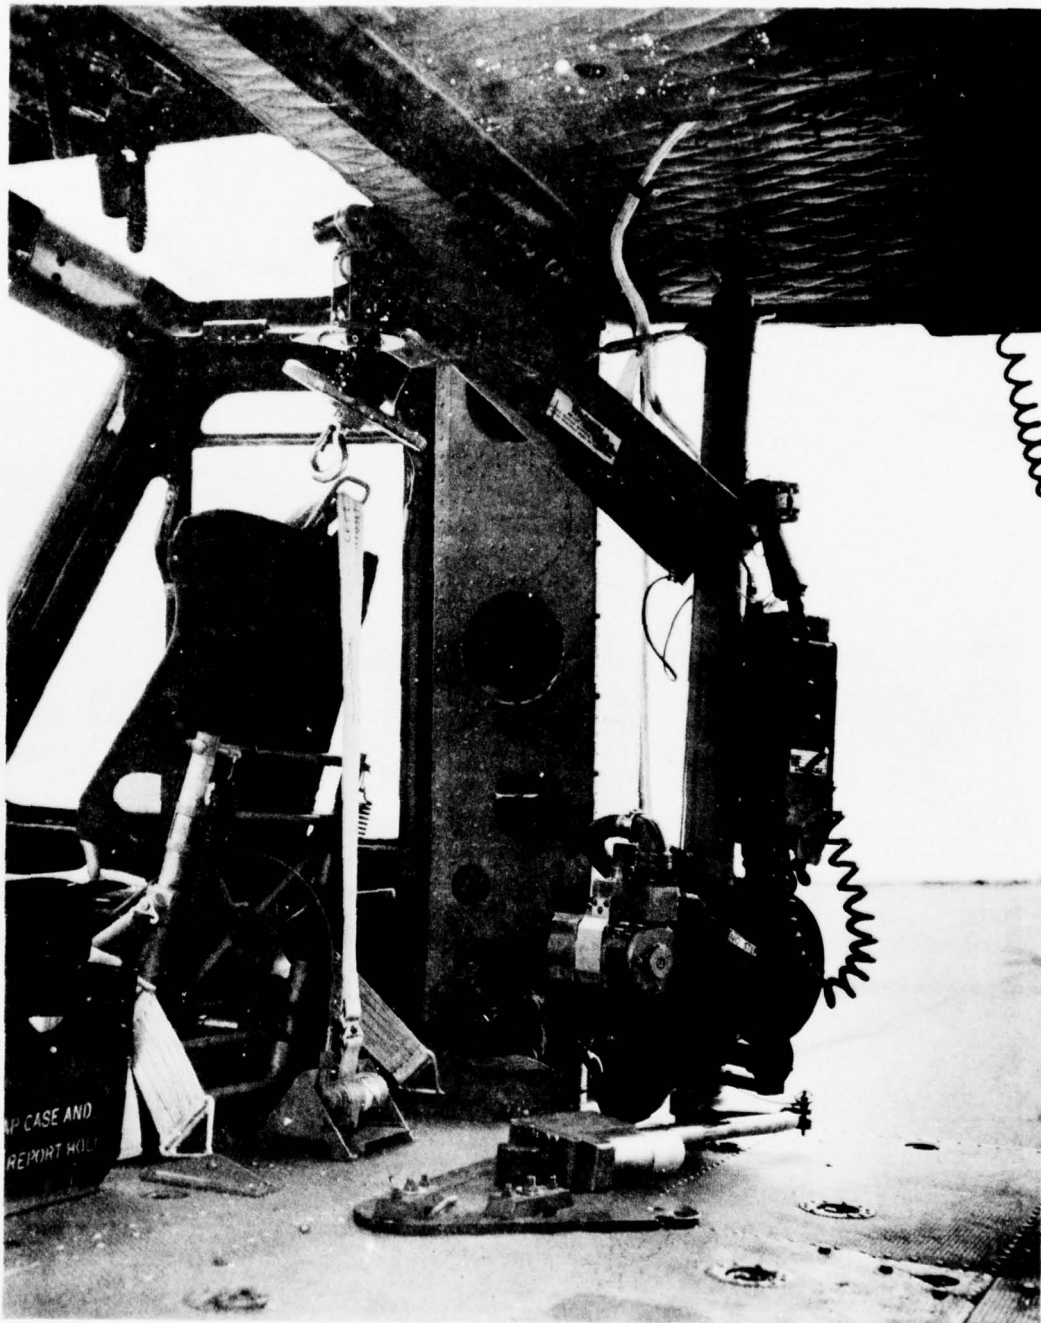
PHOTO H

Photographs A, C, E, and G illustrate the WGH hoist effect on entrance door and cabin space compared to the Breeze ECP-720 hoist photographs B, D, and F. Conservation of entrance door space, as well as absence of actuator base plate, is noted in photographs of WGH.

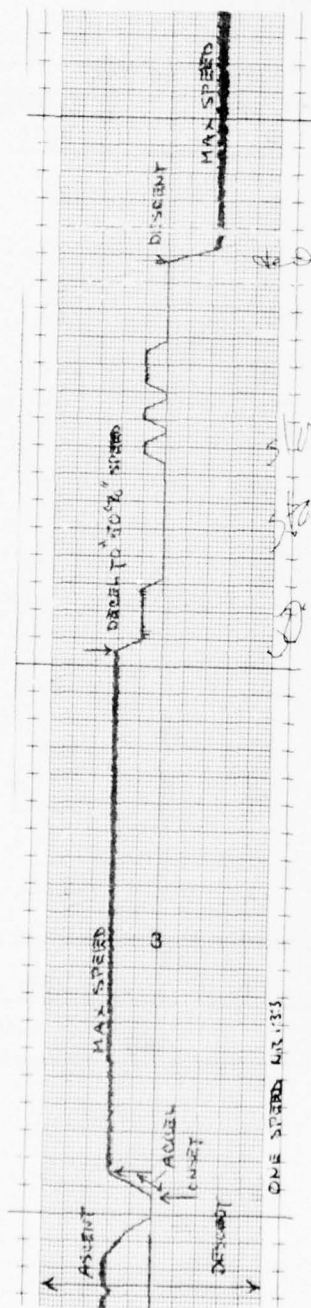
FIGURE 3 - 125 FPM

Figures 3 and 4 illustrate sample data acquisition of the velocity/acceleration profile recorded from the instrumented WGC hoists numbers 133 and 135.
